# **ACTIVE CLEANING TECHNIQUE FOR REMOVING CONTAMINATION FROM OPTICAL SURFACES IN SPACE**

**FINAL REPORT  
D180-17610-1  
AUGUST 1973**

**CONTRACT NAS8-26385**

**BY  
Boeing Aerospace Company  
Research & Engineering Division  
Seattle, Washington 98124  
A Division of the Boeing Company**

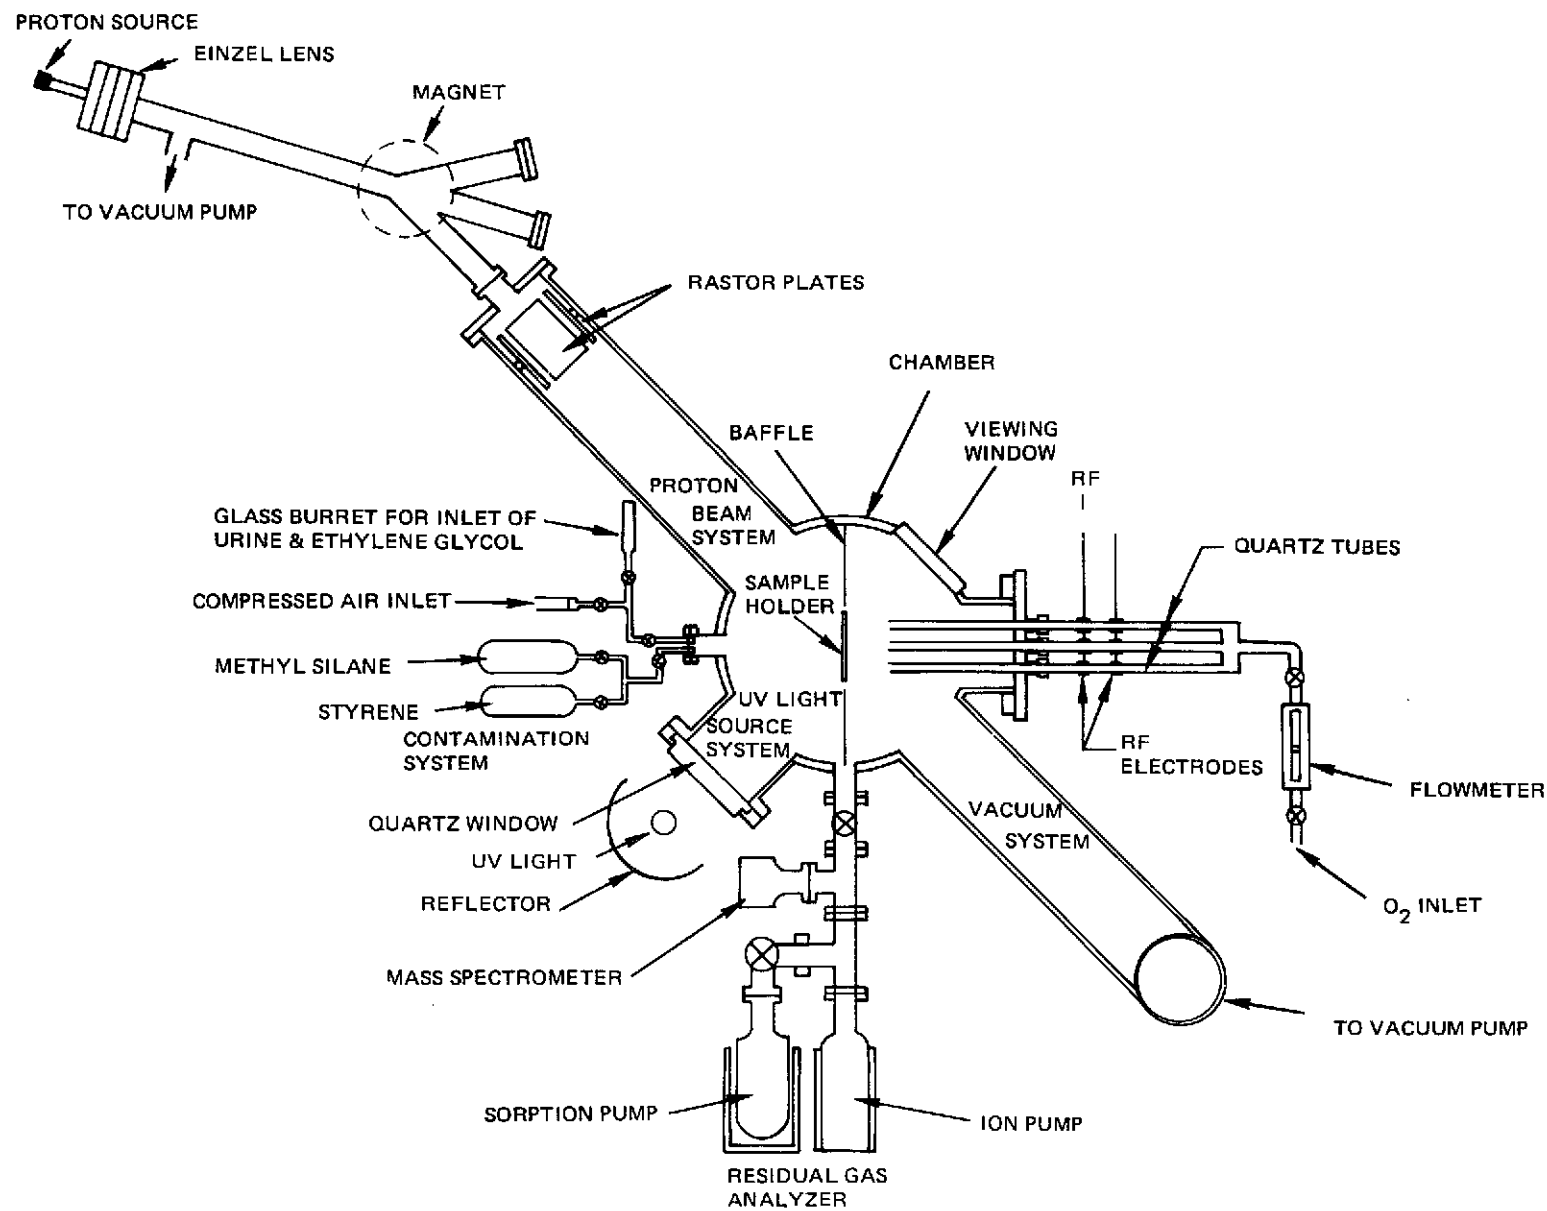
Figure 1 shows the contaminant film deposition/cleaning facility developed during the first phase of this contract. The details of this facility are described in Reference 6. A contaminant vapor source, proton accelerator, ultraviolet light source, residual gas analyzer and a plasma generator system are incorporated in the facility. The proton accelerator and residual gas analyzer were not used in the experiments described in this report. Also, only a single plasma tube was used instead of the three plasma tubes shown in Figure 1. Figure 2 shows the plasma tube configuration used in all experiments except those described in Section 4.6. The plasma tube consists of a 10 mm ID outer quartz tube, a 4 mm ID inner quartz tube and diametrically opposed tungsten wire electrodes in the annulus. The radio frequency (r.f.) power was supplied with a 13.6 MHz power supply. The plasma tube was normally operated at a nominal upstream pressure of 4 torr which produces an oxygen flow rate of about 50 STD cc/min. The resultant vacuum chamber pressure at this flow rate is in the  $10^{-3}$  -  $10^{-2}$  torr range.

Figure 1: CONTAMINANT FILM DEPOSITION/CLEANING FACILITY

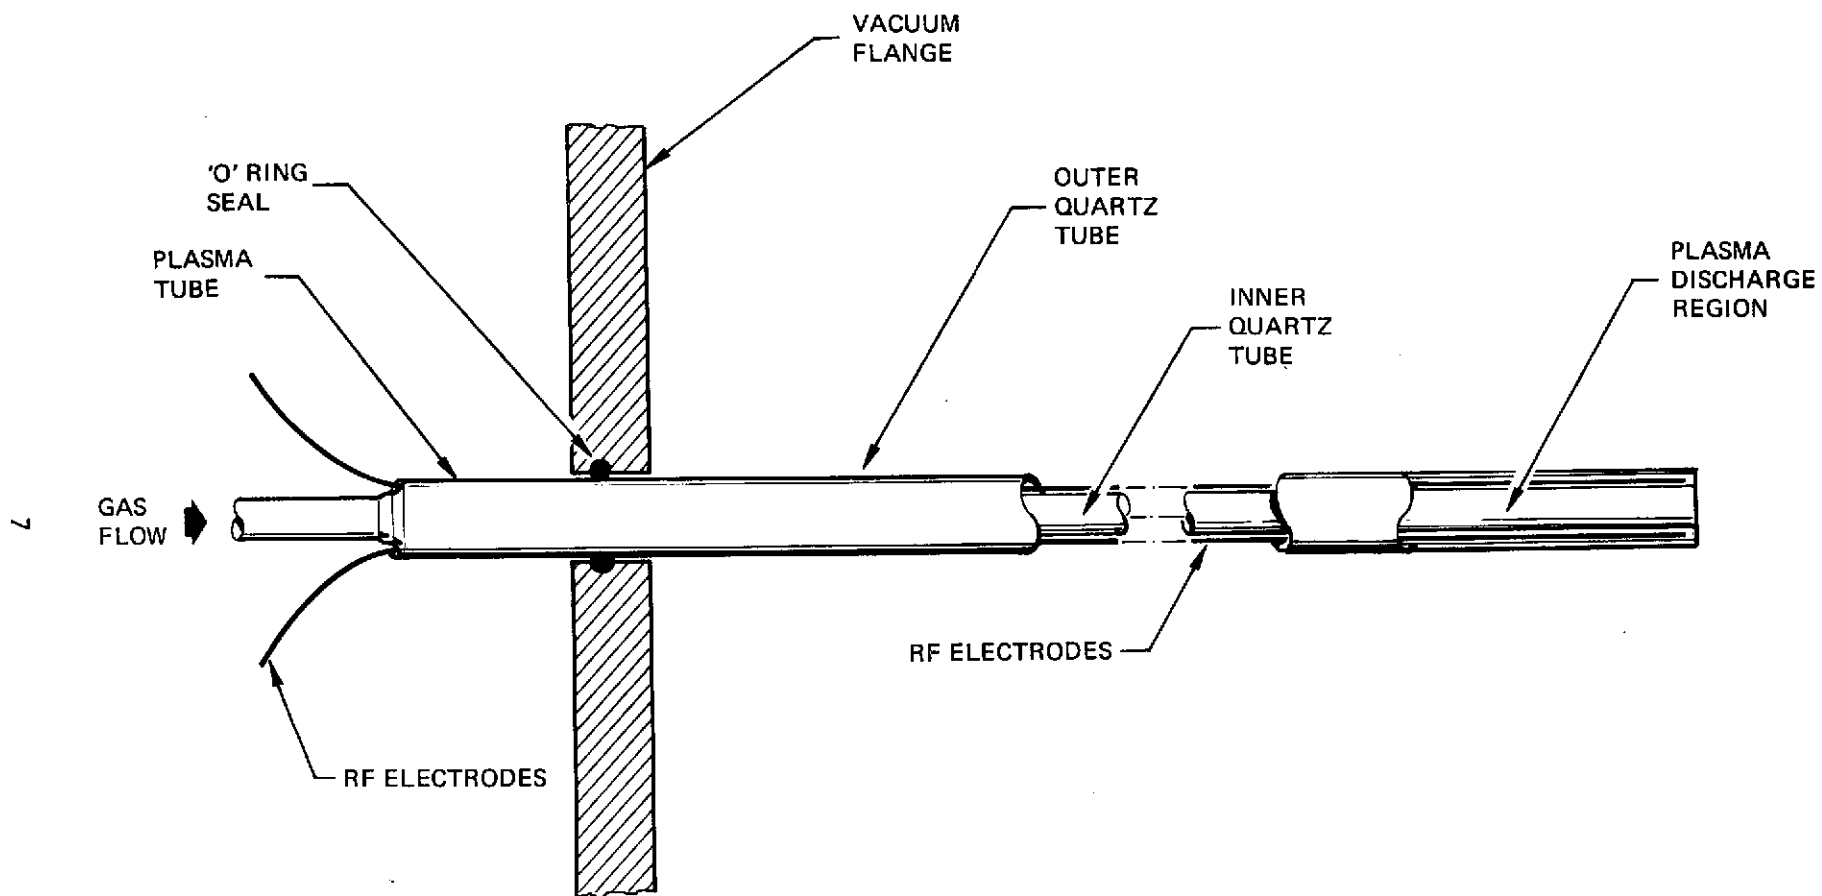
Figure 2: PLASMA TUBE CONFIGURATION

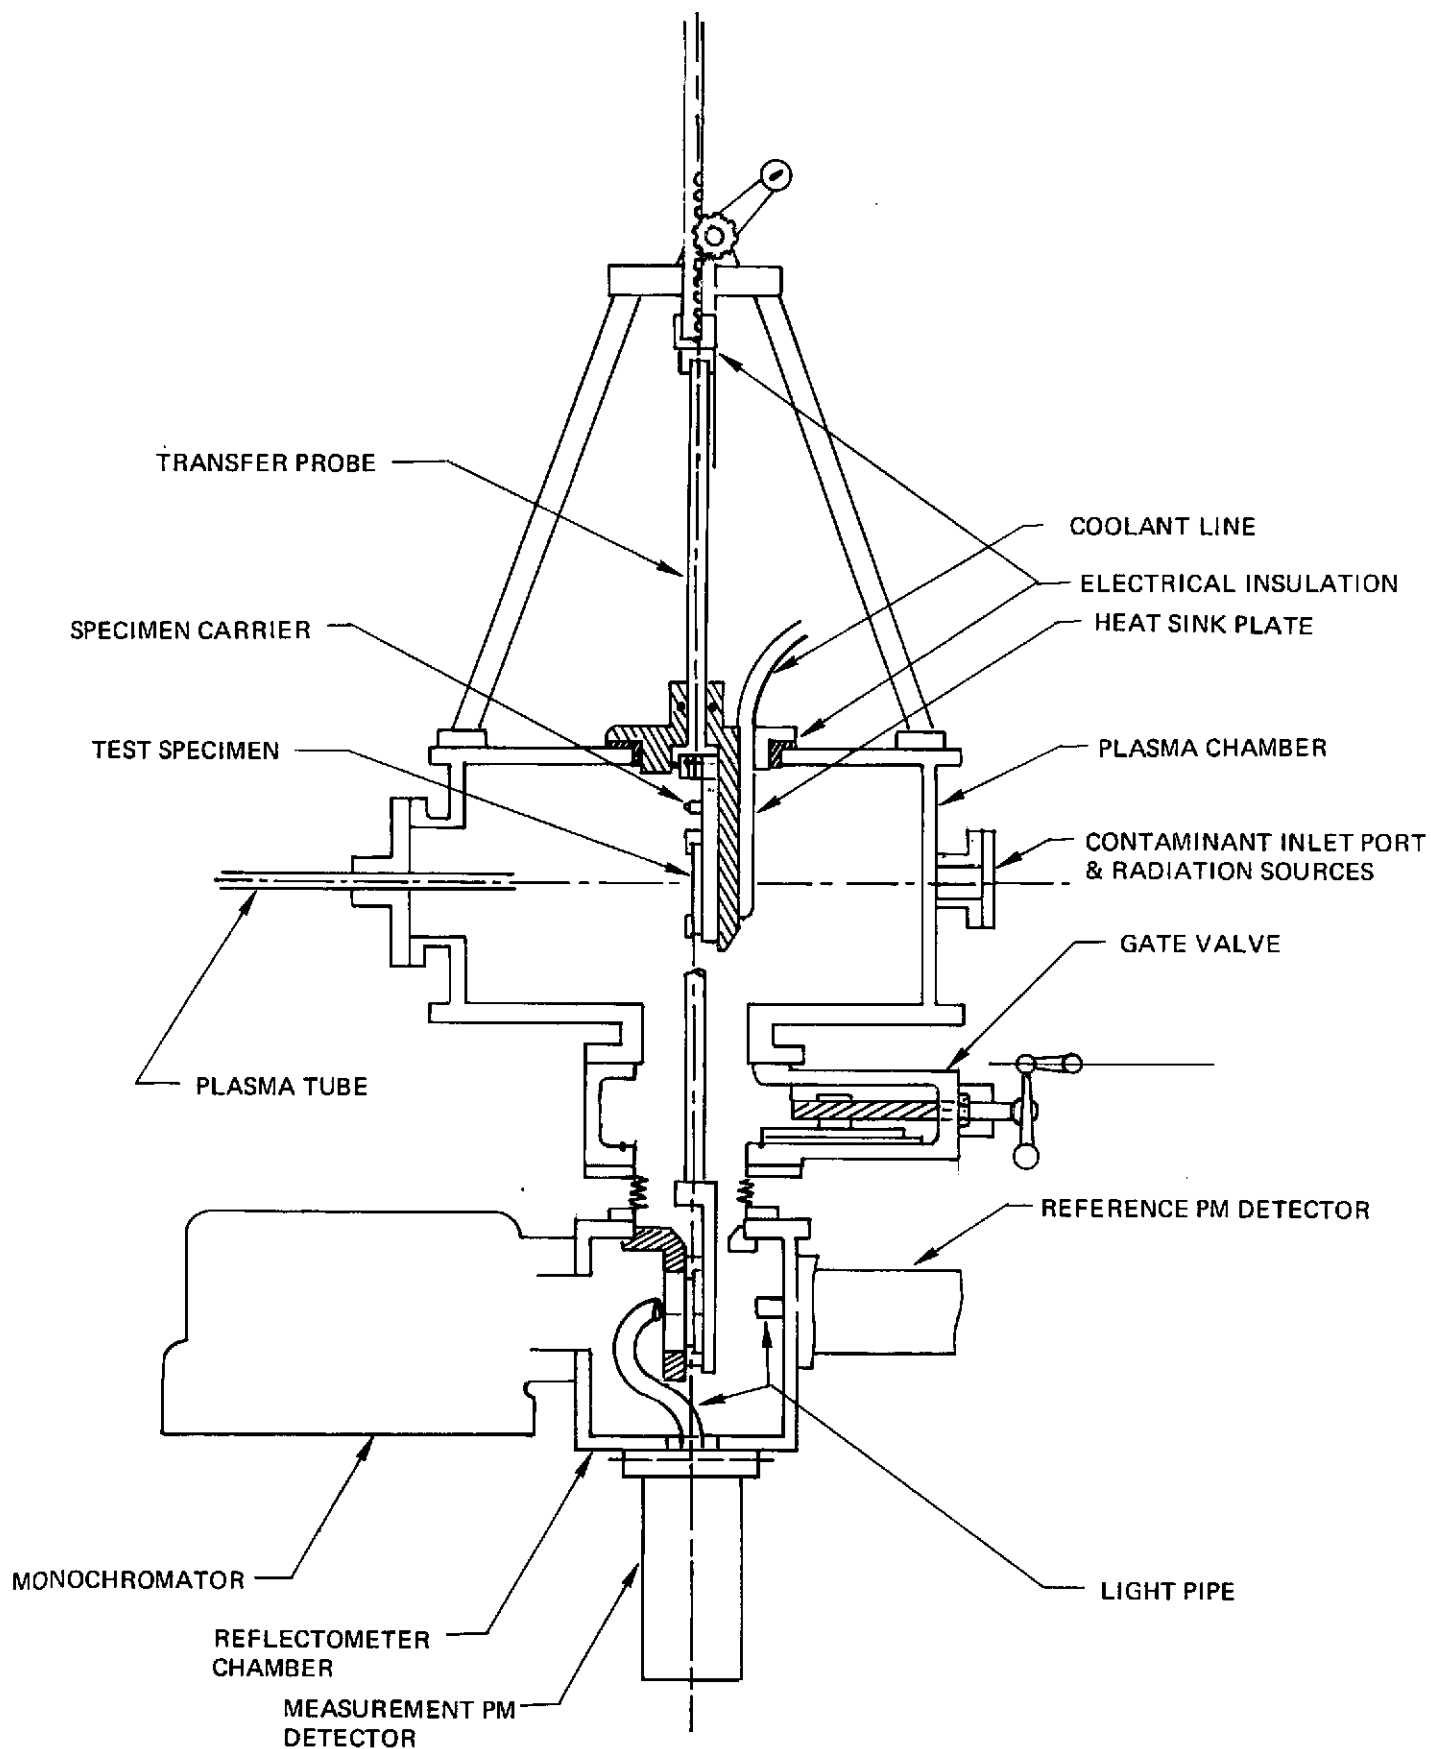
An ultraviolet reflectometer was prepared which could be used in conjunction with the existing plasma cleaning/contamination facility. This instrument allows reflectance measurements to be made before and after contaminant deposition and plasma cleaning, without exposing specimens to ambient pressure. In prior experiments (Reference 6) specimens had to be transferred in air to the ultraviolet reflectometer, thus introducing possible chemical and optical changes in the contaminant films.

Figure 3: SCHEMATIC OF IN-SITU UV REFLECTOMETER

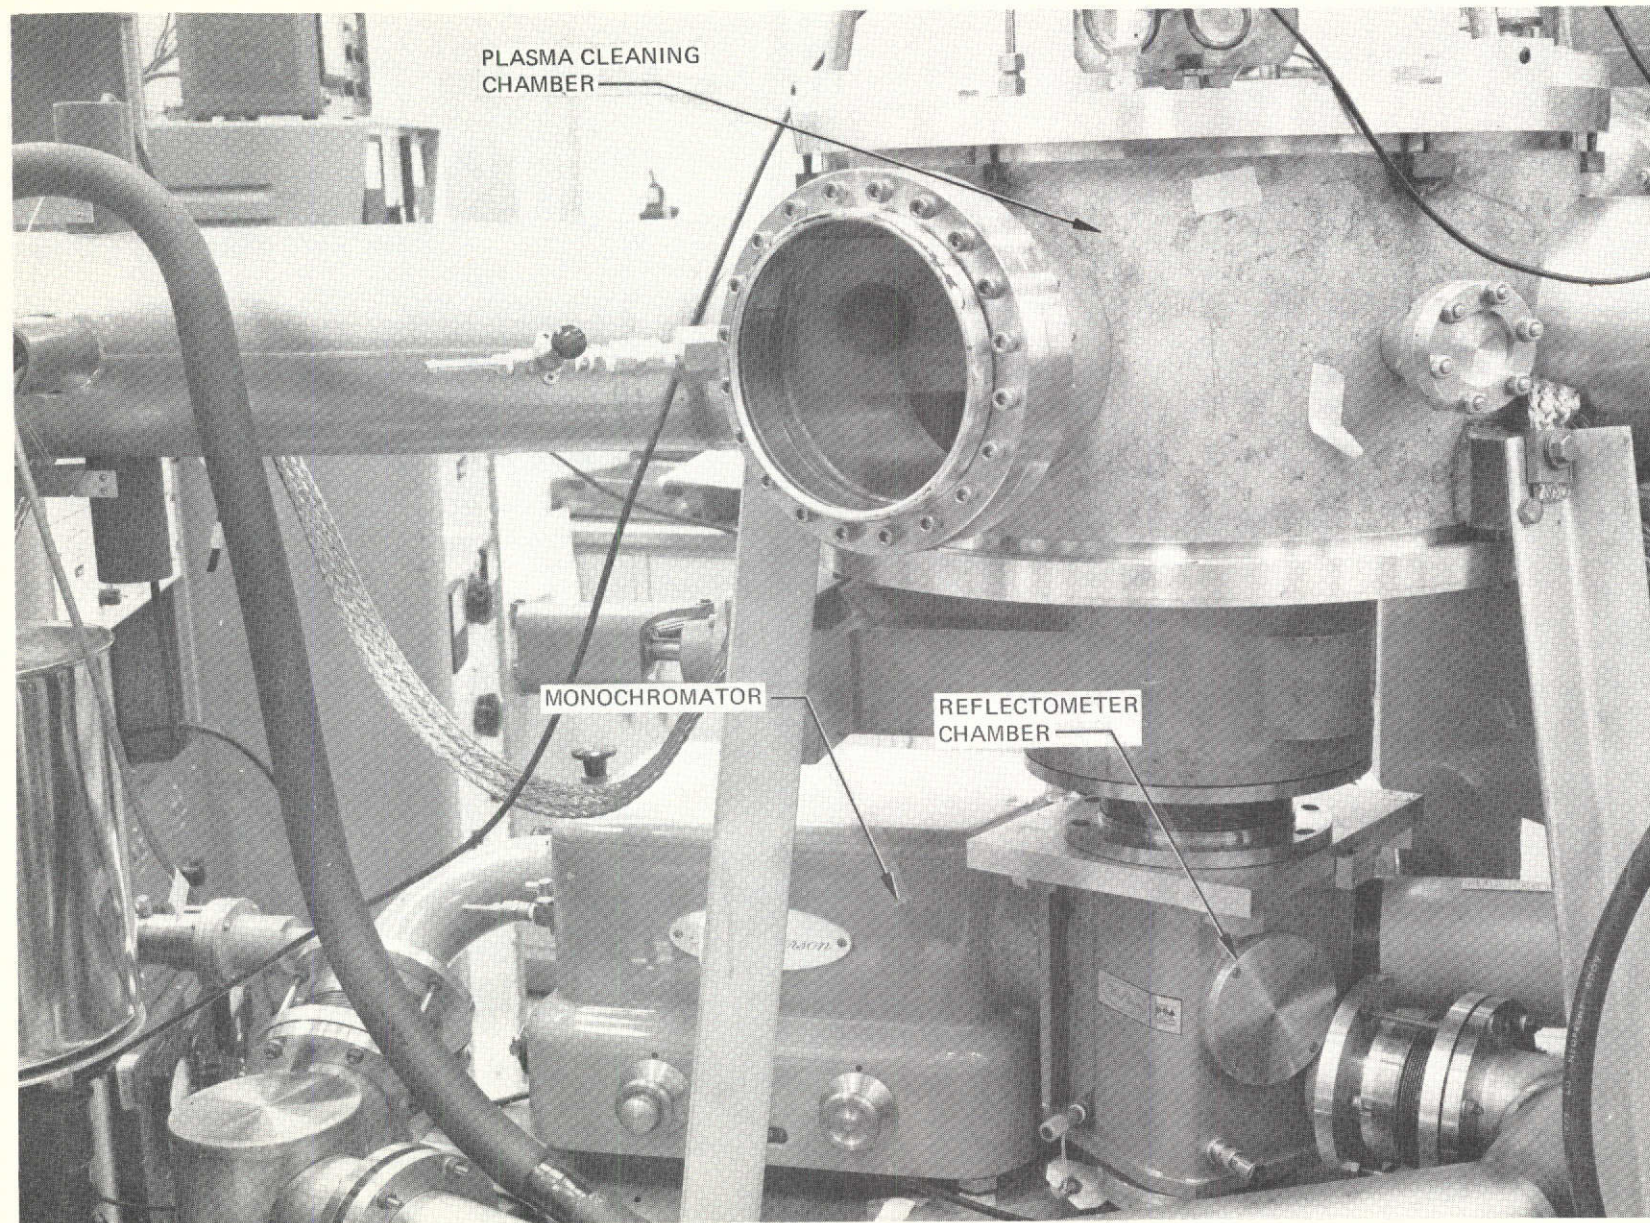
Figure 4: PLASMA CLEANING FACILITY

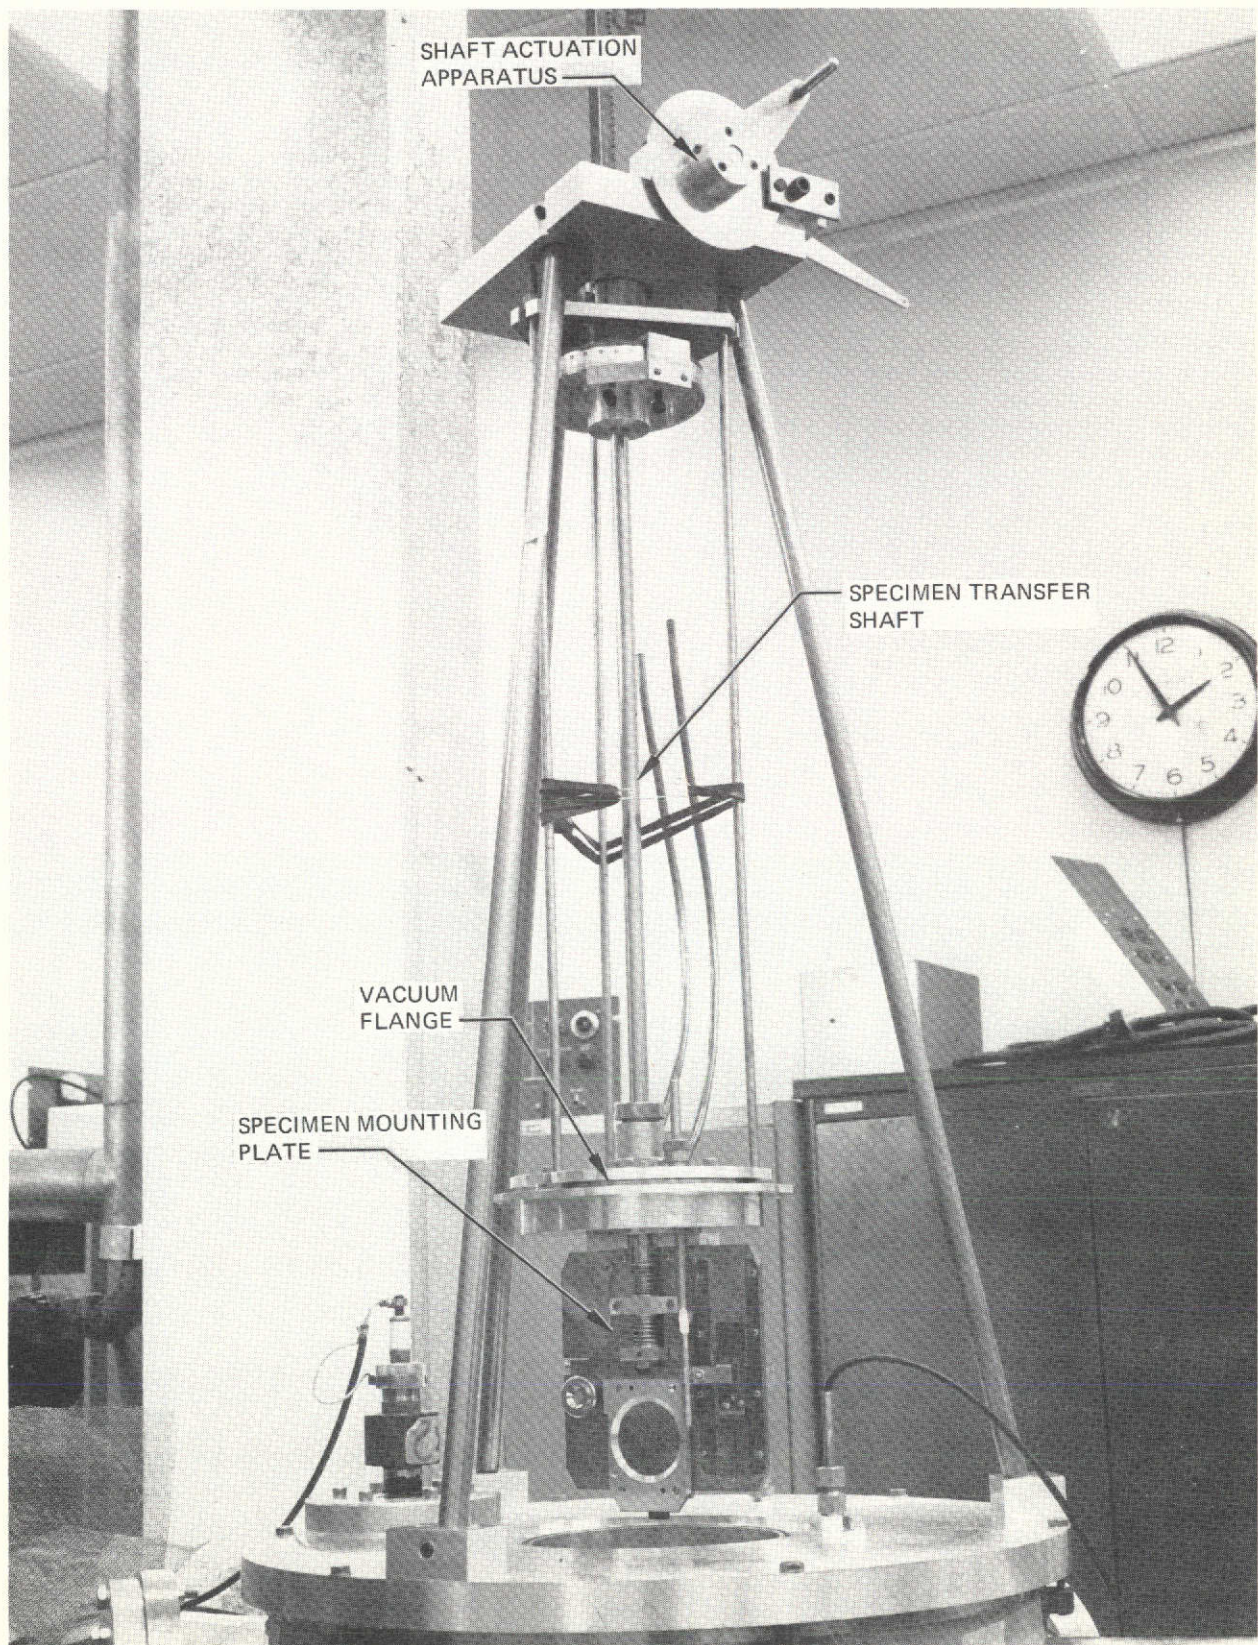
*Figure 5: APPARATUS USED FOR TRANSFERRING SPECIMEN FROM PLASMA CLEANING CHAMBER TO REFLECTOMETER*

The specimen mounting fixture and heat-sink plate are designed such that they can be retracted from the plasma chamber by upward linear motion of the transfer probe. Also, they can be rotated 360 degrees (with respect to the probe axis), and are electrically isolated from the chamber. Withdrawal of the entire assembly from the chamber facilitates installation of specimens. The rotational feature of the specimen mounting apparatus allows it to be oriented towards the plasma generation tube, the contaminant inlet port, and ultraviolet or proton radiation sources. The capability to electrically isolate specimens from the chamber may be useful for future contamination and cleaning experiments.

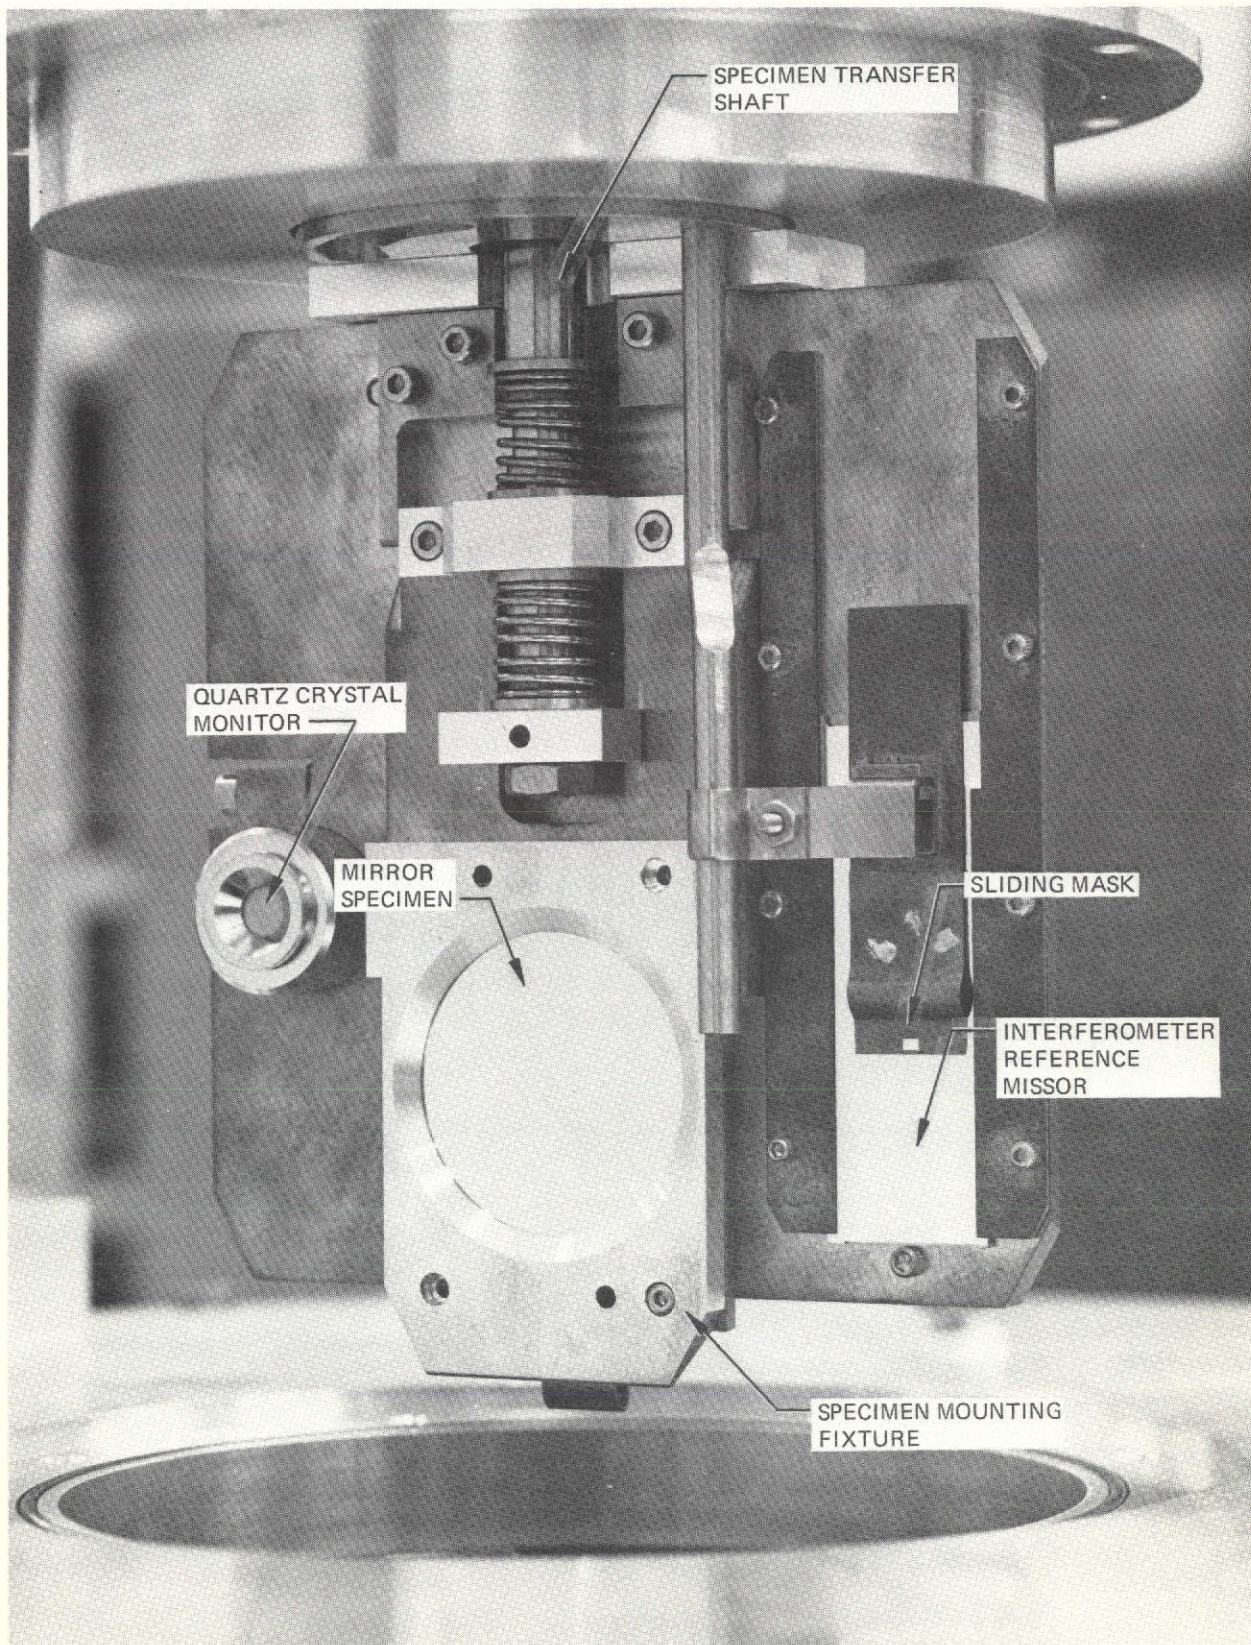
A detailed view of the specimen mounting plate and associated hardware is shown in Figure 6. The mirror specimen is mounted in a fixture which is located at the lower center of the plate. The mirror fixture locks onto the copper mounting plate when the transfer shaft is in its upper position, and releases from the plate when the shaft is lowered. A quartz crystal monitor (QCM) is mounted on the plate at the left side of the specimen. An interferometer reference mirror (IFM) for contaminant film thickness measurements is mounted at the right side of the specimen. A thin brass cover can be moved along the surface of the IFM to protect contaminated or cleaned areas from additional plasma exposure. The cover is actuated with a translational/rotational shaft which passes through a vacuum seal in the plasma chamber wall.

Figure 6: SPECIMEN MOUNTING PLATE

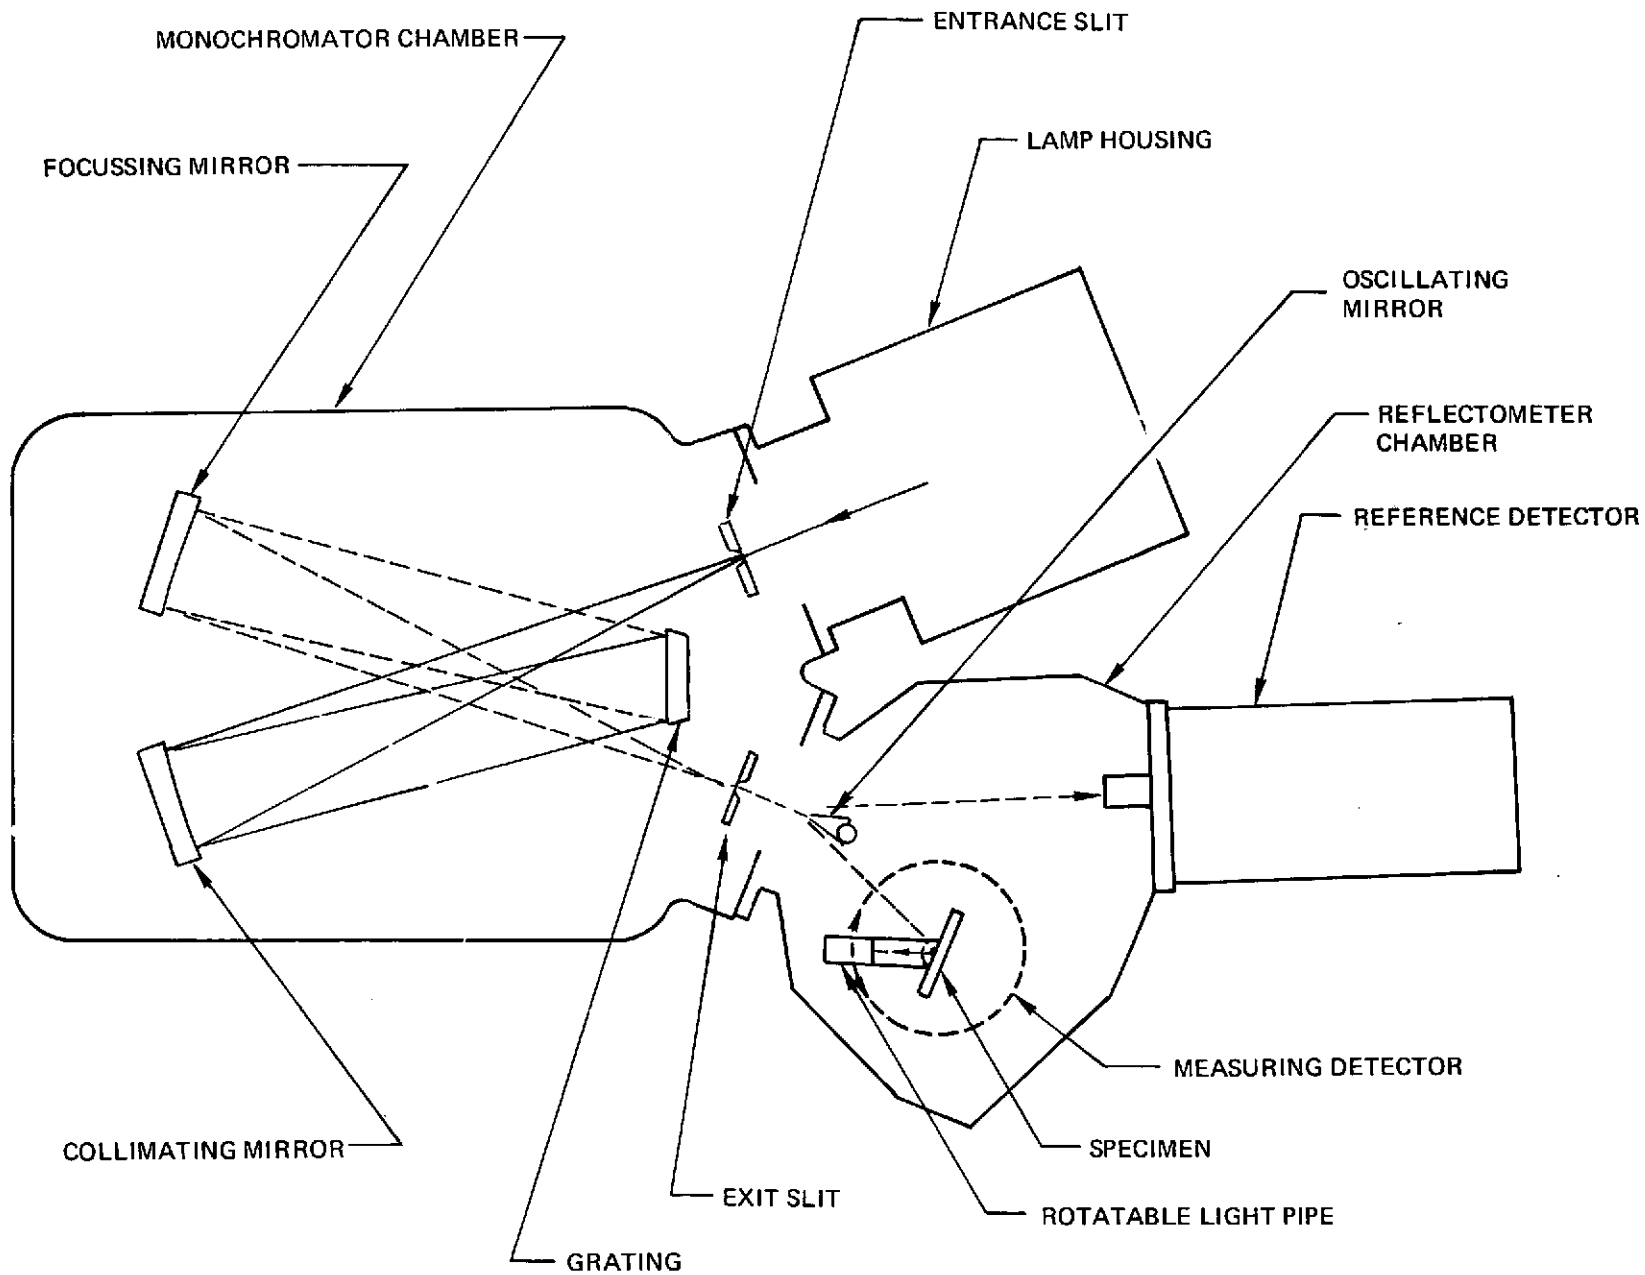
Details of the reflectometer optical system are shown in Figure 7. A conventional Hinteregger gas discharge lamp is used as the light source for the monochromator. As shown in the figure, light from the entrance slit is collimated and directed to the grating. Reflected light from the grating illuminates a second concave mirror and is focussed on the exit slit. The grating is ruled with 600 lines/mm, blazed at 150 nm wavelength, and employs an aluminum reflective coating which is overcoated with  $\text{MgF}_2$ . Light entering the reflectometer chamber is reflected by an oscillating mirror to the reference PM detector and the measuring PM detector. Both detectors utilize a sodium-salicylate-coated light pipe to transmit radiation from the chamber to the PM tube cathode. The measuring detector has a rotatable U-shaped light pipe such that it can view either the reflected light from a mirror specimen or the light incident on the specimen. The latter measurement is made by removing the mirror from the light path and orienting the light pipe to view direct light

Figure 7: LIGHT PATH SCHEMATIC FOR IN-SITU ULTRAVIOLET REFLECTOMETER

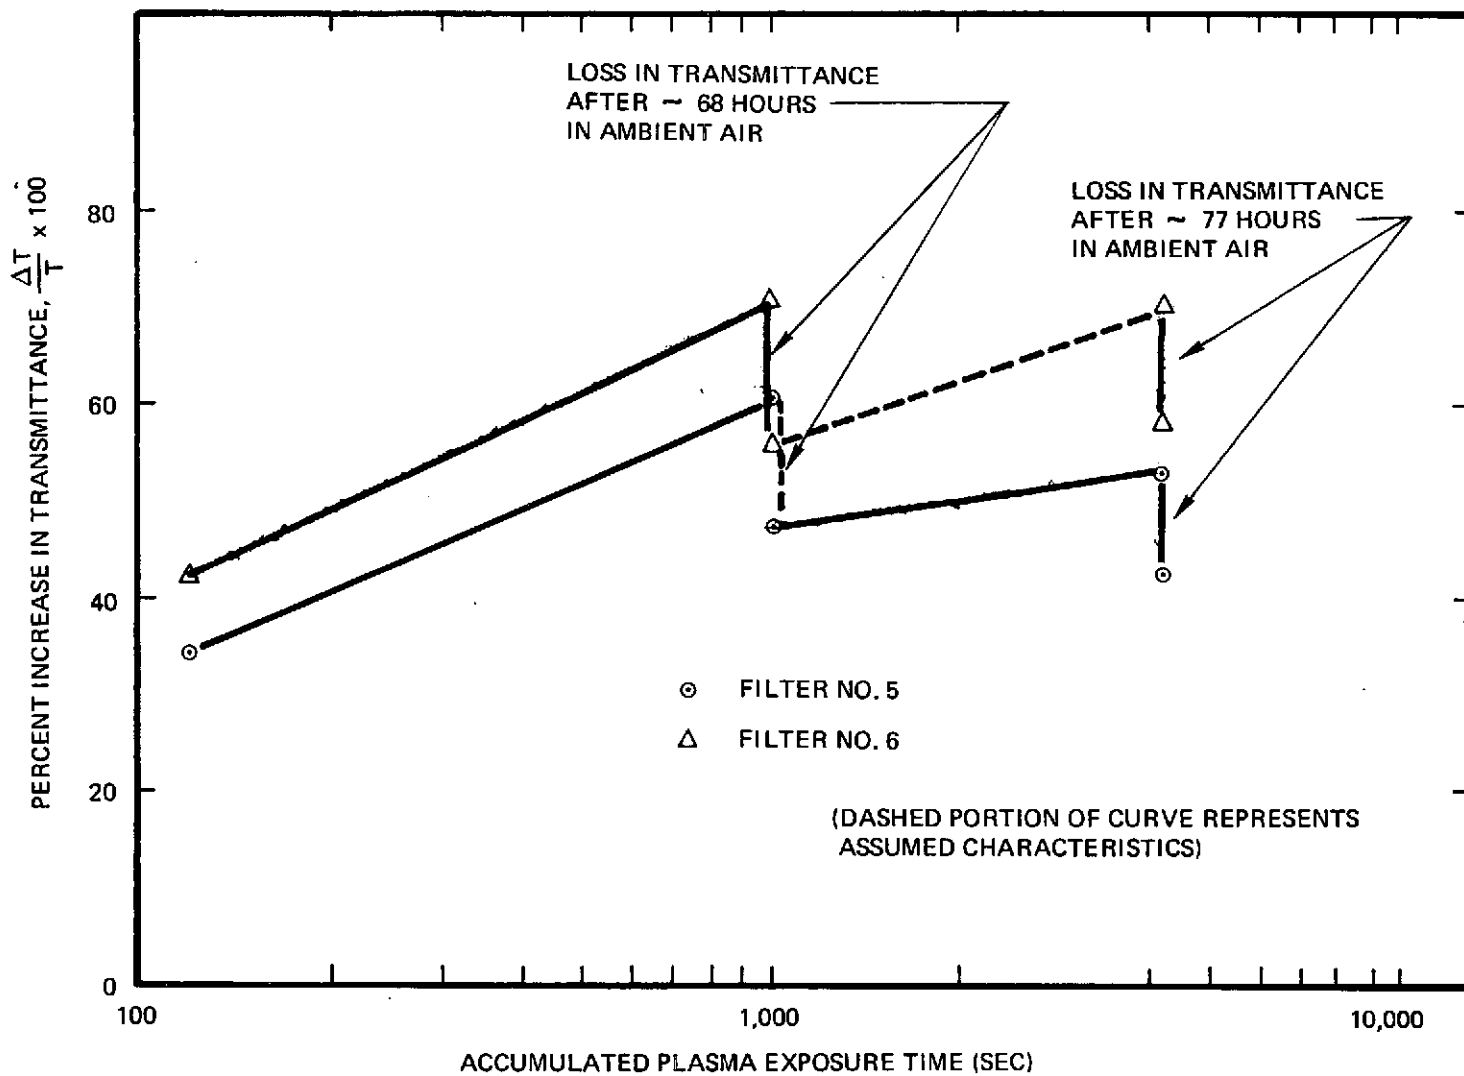
Figure 8: THE EFFECT OF OXYGEN PLASMA EXPOSURE AND AMBIENT AIR EXPOSURE ON ATM FILTER NOS. 5 AND 6

After about 68 hours in ambient air, filter No. 5 was remeasured and a slight loss in transmittance was observed (Figure 8). Subsequently, filter No.'s 5 and 6 were exposed for an additional 2360 secs in an oxygen plasma. The transmittance of filter No. 5 once again increased, but only slightly. Remeasurement after a period of about 77 hours in ambient air again showed a slight decrease in the transmittance of each filter (Figure 8). It must be concluded that exposure to ambient air following treatment will produce a slight decrease in transmittance of aluminum filters.

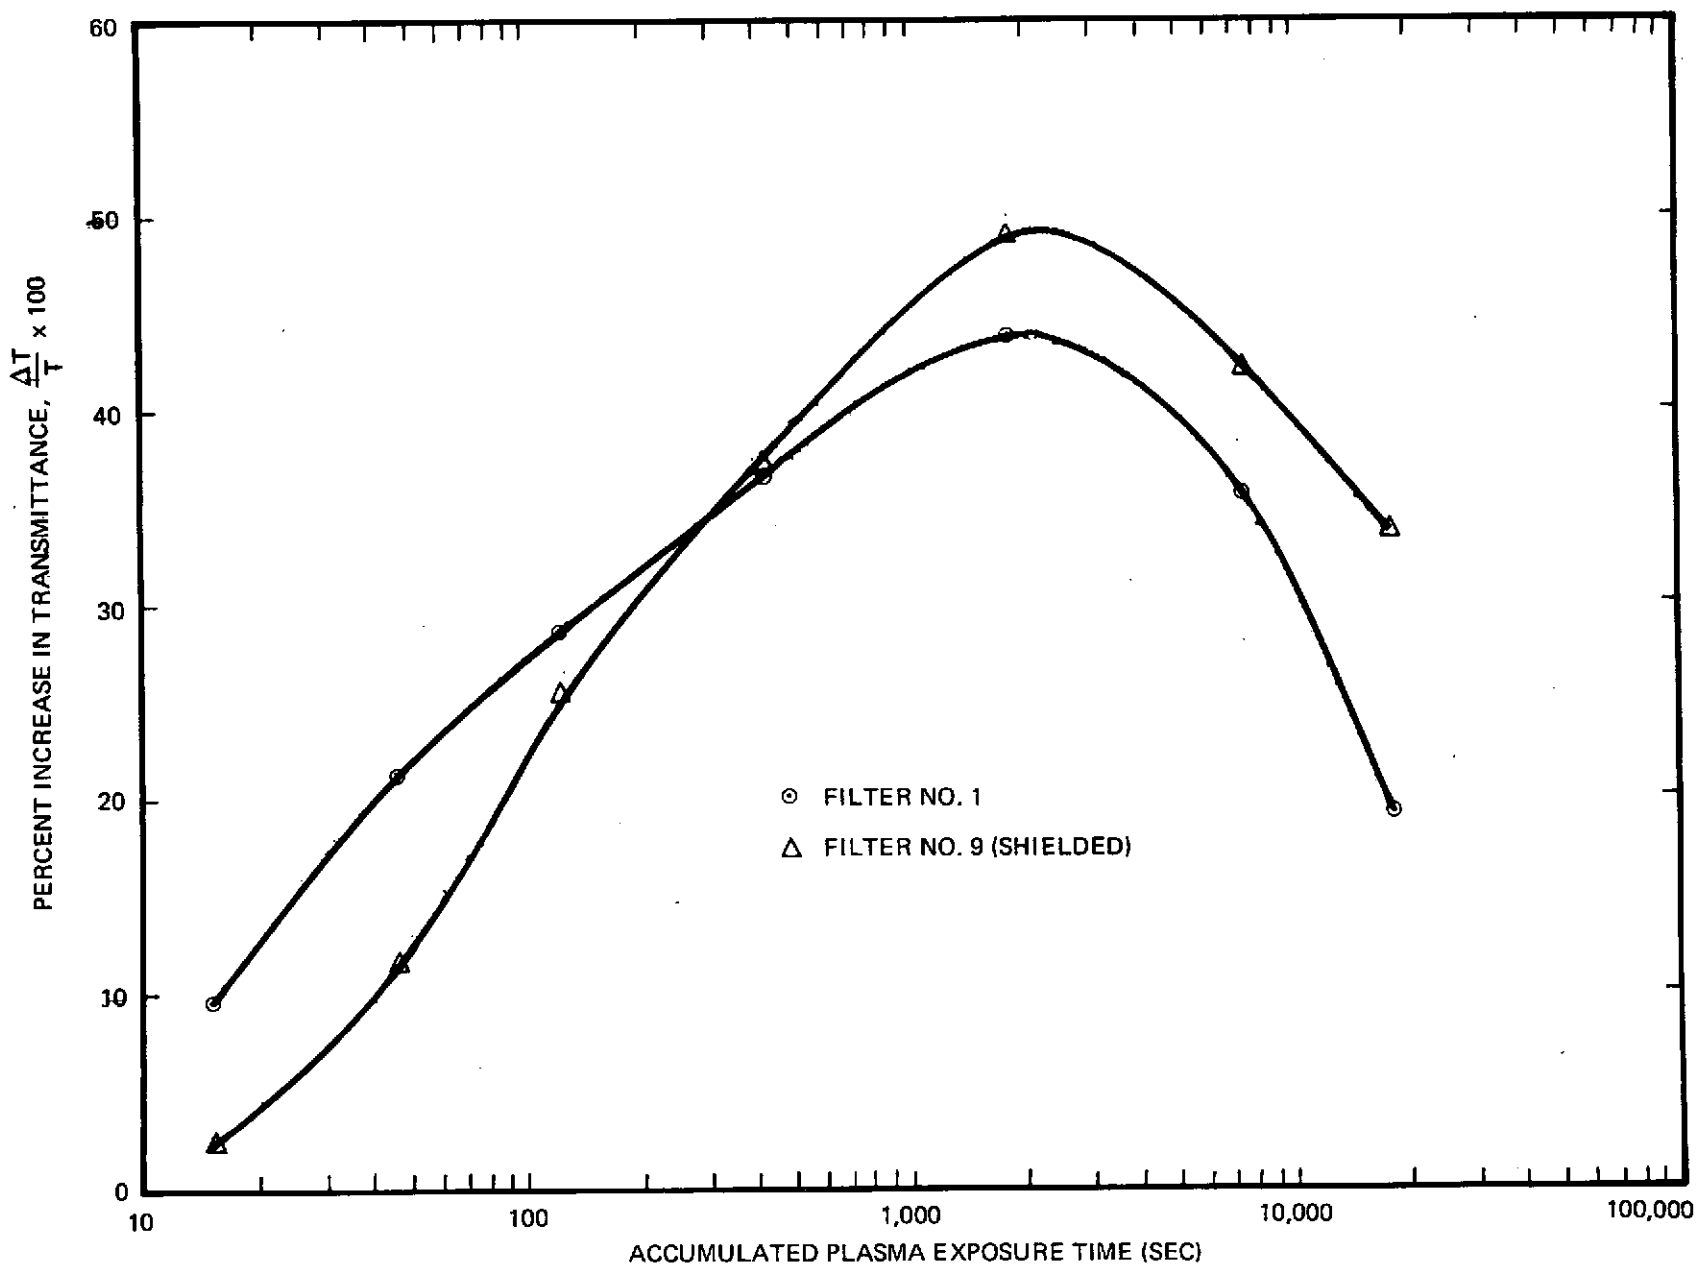
Figure 9: THE EFFECT OF OXYGEN PLASMA EXPOSURE ON UNSHIELDED AND SHIELDED ATM FILTER NOS. 1 AND 9

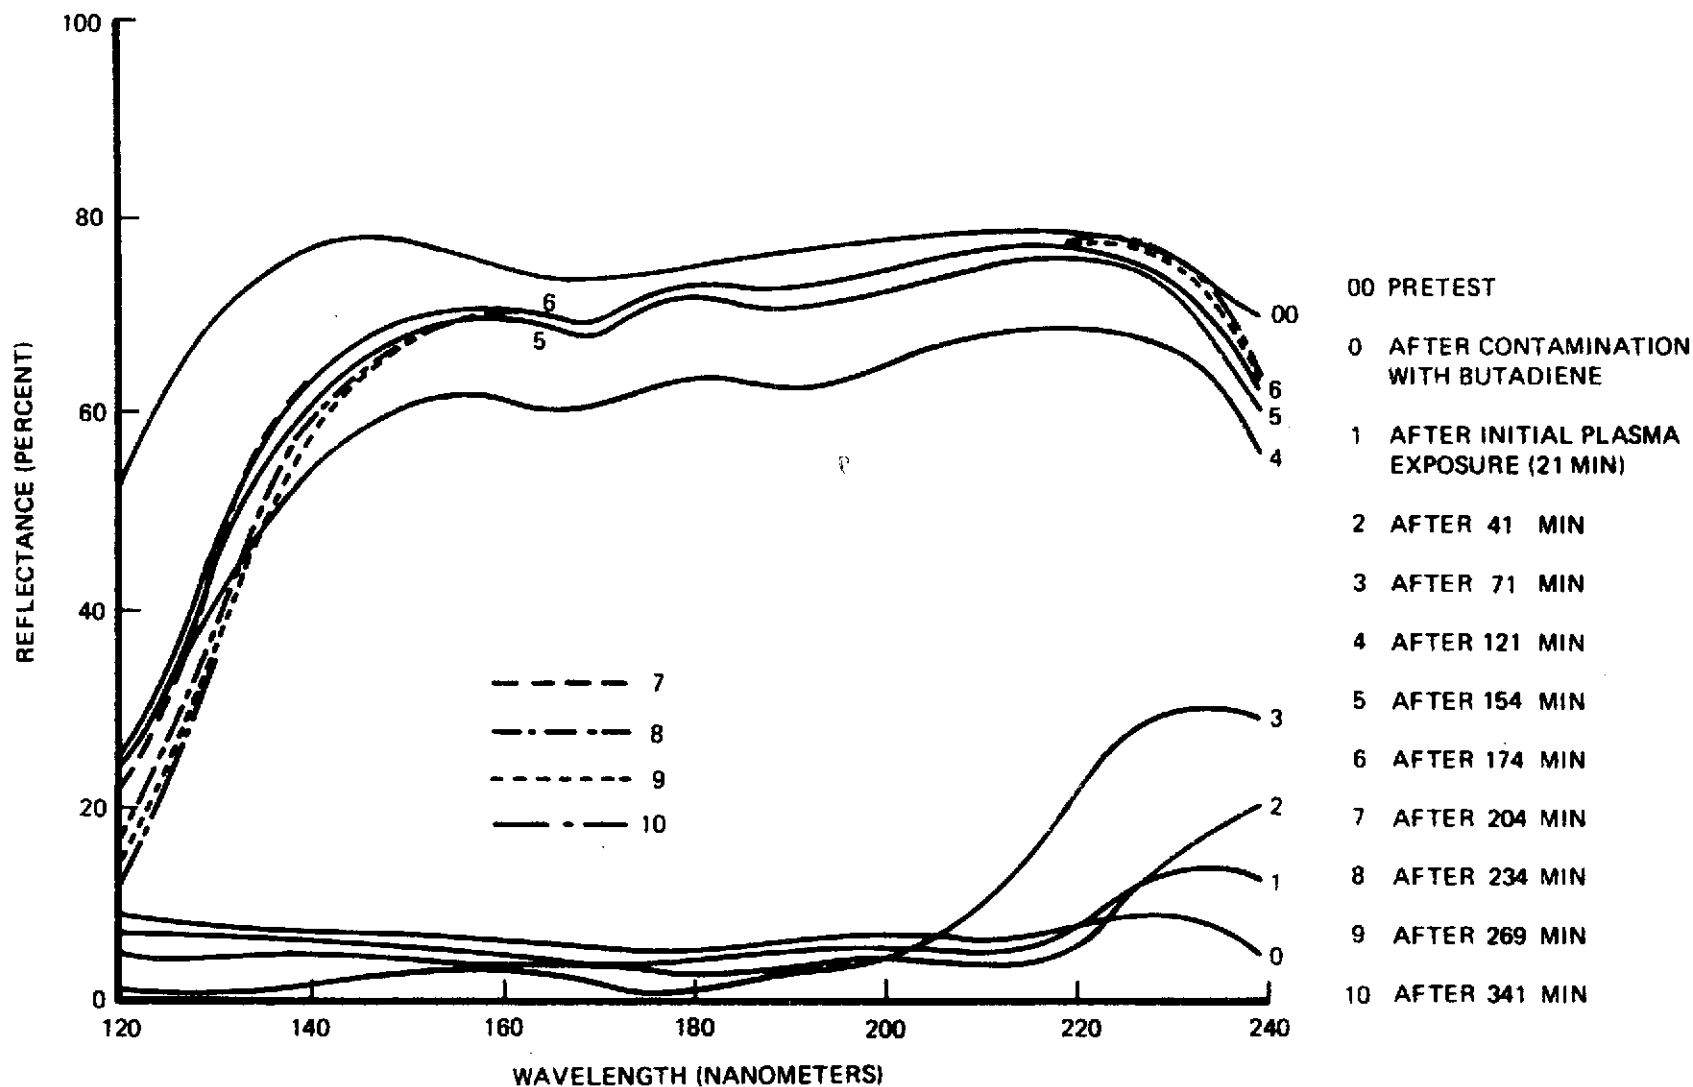
Figure 10: EFFECT OF BUTADIENE CONTAMINATION AND PLASMA EXPOSURE ON REFLECTANCE OF  $1/2\lambda - \text{Mg F}_2/\text{Al}$  COATED MIRROR (NO Mg F-39)

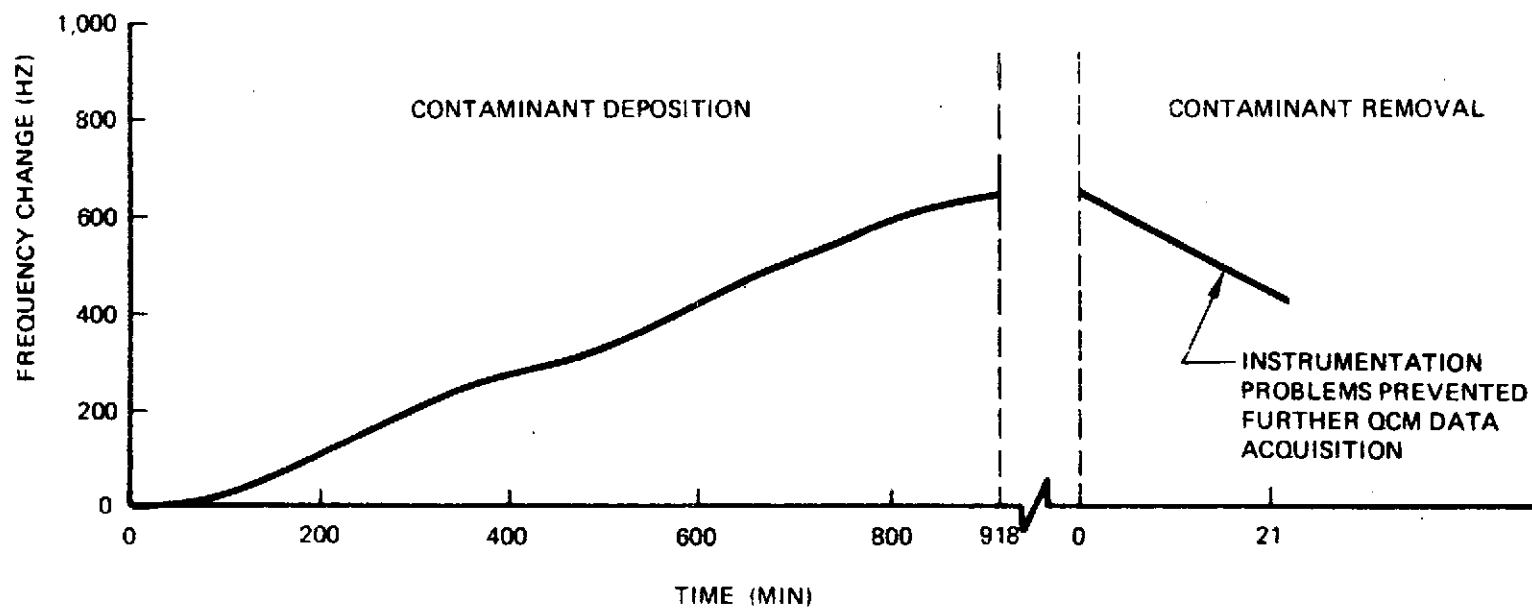
Figure 11: QCM RESPONSE TO BUTADIENE CONTAMINATION AND OXYGEN PLASMA EXPOSURE
